**Caring for Gresley carriages on the Severn Valley Railway  
The Railway Station, Bewdley, Worcestershire, DY12 1BG**

**LNERCF & LNERCG NEWSLETTER No.3 1**

**PUTTING IT ALL BACK TOGETHER AGAIN!**

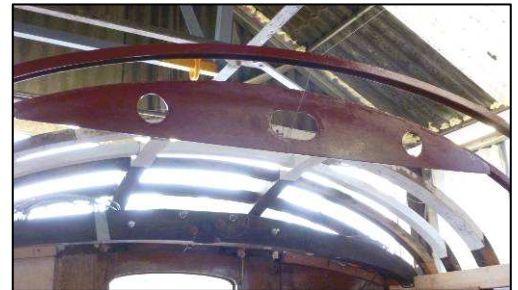
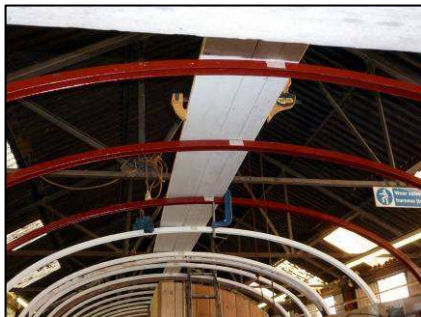
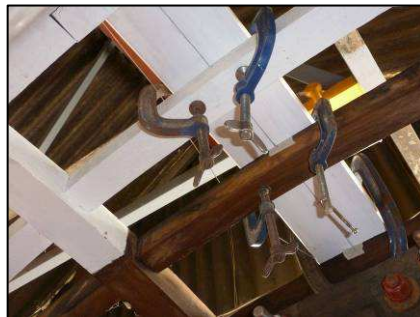
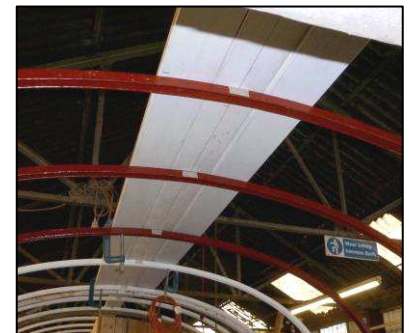
After several repairs to the roof timber framing, we can now see the first stages of fitting the new roof timbers. Great care is needed to set up the centre line of the first of these, and here we are in the good hands of

Marsh Kirby who is one of SVR's professionals in this department. The first timbers were aligned in place on 4<sup>th</sup> September. Below are pictures showing the early progress – including the tricky section at the carriage end where the traditional Gresley roof forms an elegant downward curve.

Once all the roof timbers are in place, the roof will get its canvas covering. This is laid on a compound that can perhaps politely be described as 'gloop', though there are a few 'more robust' names for this substance! Despite the innocent description of 'Roof Canvas Bonding' on the tins, this is one of the most disgusting fluids on the planet. It is foul in appearance, texture and smell and gets everywhere and on everything. But it forms a good base to receive the canvas and ensures a long life for the protection that the finished canvas gives from the elements. The final stage will be coats

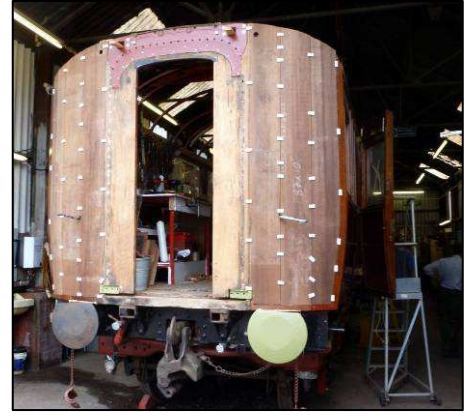
And, with winter and its weather peeping over the horizon, the opportunity to apply more coats of protective varnish to the body sides is too good to miss while we have 70759 under cover. The resultant extra coats can only be described as stunning. These two pictures give a glimpse.

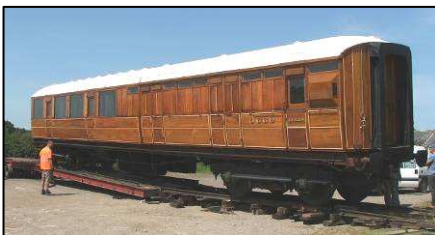
This picture shows Gresley Diagram 114 Brake Third No.3669 being delivered to Pickering earlier this year, following its superb 10-year restoration from an empty shell in poor condition. The carriage is close to its launch into North Yorkshire Moors Railway service. This is another important milestone in perpetuating the heritage and history of the LNER and Gresley eras. NYMR guards may, however, have cause to envy those on SVR, who will have 70759's heated compartment rather than the usual draughty corner.
