Caring for Gresley carriages on the Severn Valley Railway
The Railway Station, Bewdley, Worcestershire, DY12 1DP

LNERCF & LNERCG NEWSLETTER No.50

24506 EMERGES INTO THE SUNSHINE!

February 2016

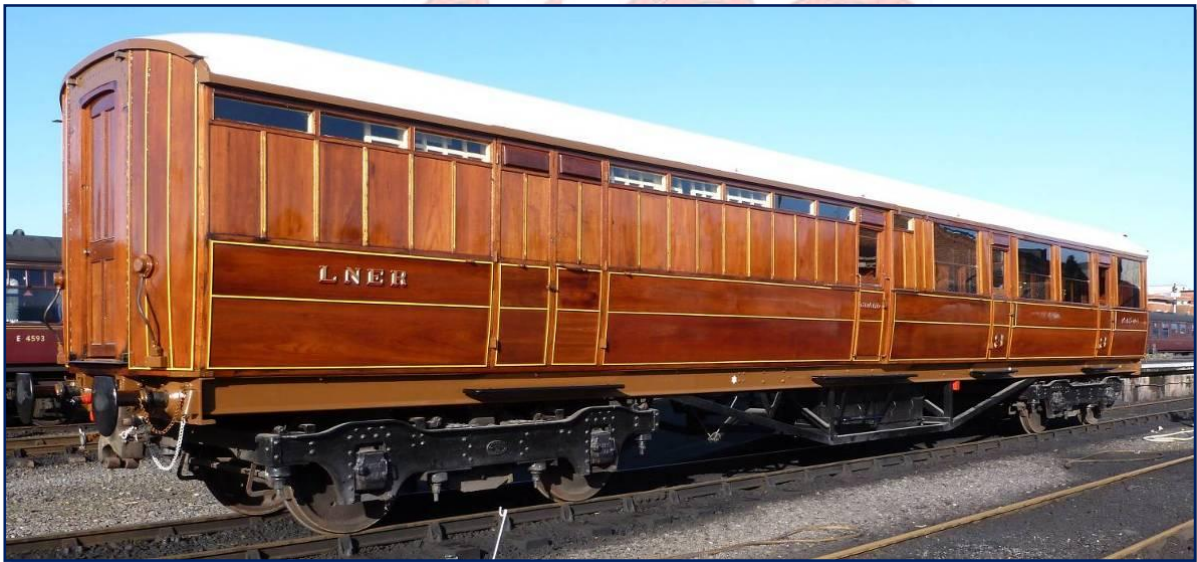
Tuesday 9th February was an historic day for the new Brake Third No.24506 when it emerged from Kidderminster C&W Paint Shop into that morning's lovely winter sunshine. Looking a (nearly) complete Gresley carriage, it has now moved into Kidderminster Carriage Shed for a short period while it awaits a slot for its mechanical and electrical overhaul and transfer onto its own restored bogies – here shown awaiting their own move into the Works.

During the shunt movements the Brake Third was briefly coupled to Tourist Open Third (TTO) 52255, which itself was on its way into the Carriage Works for completion of its own internal restoration. The second small picture is an interesting contrast between a newly varnished vehicle and one that has done nine years' service since it last saw a varnish brush. Nine years between re-varnishing is far too long! The final small picture (© Mike Cranmore) shows the remaining centre of pigeon van 70759's underframe now serving as a workbench for corridor gangway repairs and overhauls.

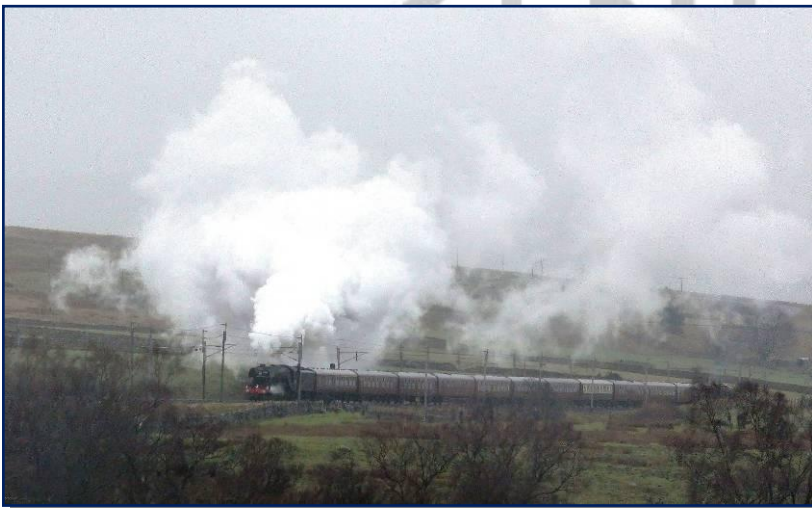
This lovely shot shows 60103 FLYING SCOTSMAN making light work of climbing Shap on its recent main line loaded test run. The picture is © Rodney Towers, who is one of our LNER Coach Association friends on the North Yorkshire Moors Railway. And, yes, the A3 is hauling eleven BR Mark I coaches plus a diesel in the end to provide the electric train heating.
